LIMITED MOLD ASSESSMENT REPORT

Austin County Building
Texas A&M AgriLife Extension Service & EMS Section
800 E. Wendt Street
Bellville, Texas 77418

Subject: Limited Mold Assessment Findings

Date Inspection Conducted: September 28, 2023

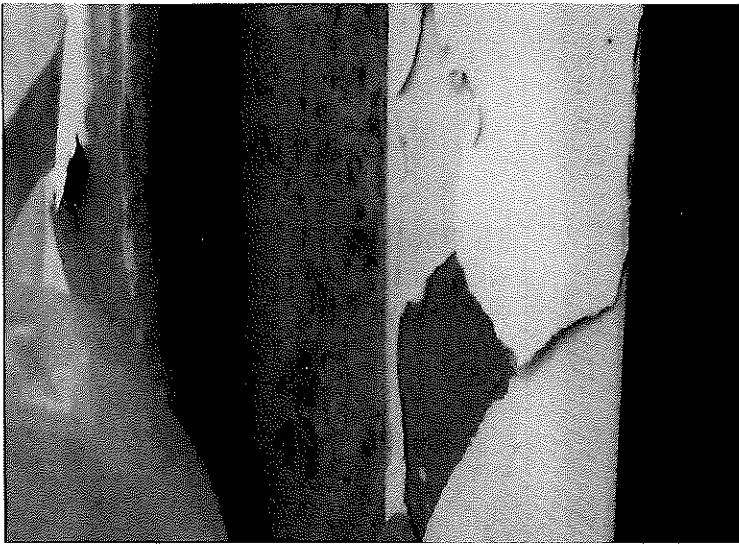
7. Mold Surface Swab Sample 04 –
Conference Room 4, north open wall
cavity drywall

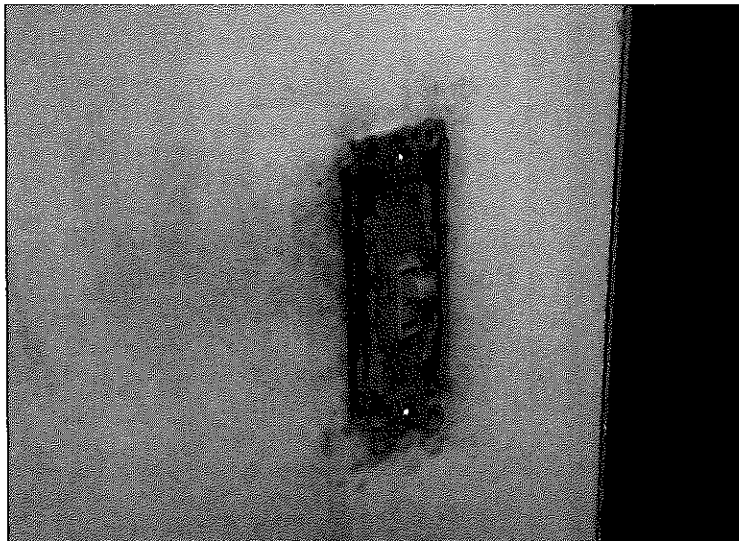
8. Mold Surface Swab Sample 05 –
Conference Room 2, east wall at
electrical switch

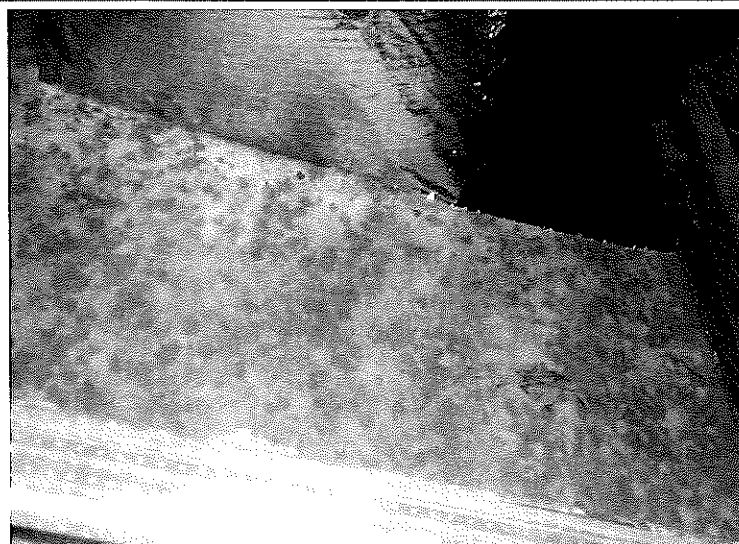
9. Mold Surface Swab Sample 06 –
Conference Room 4, upper east
drywall wall above ceiling tiles

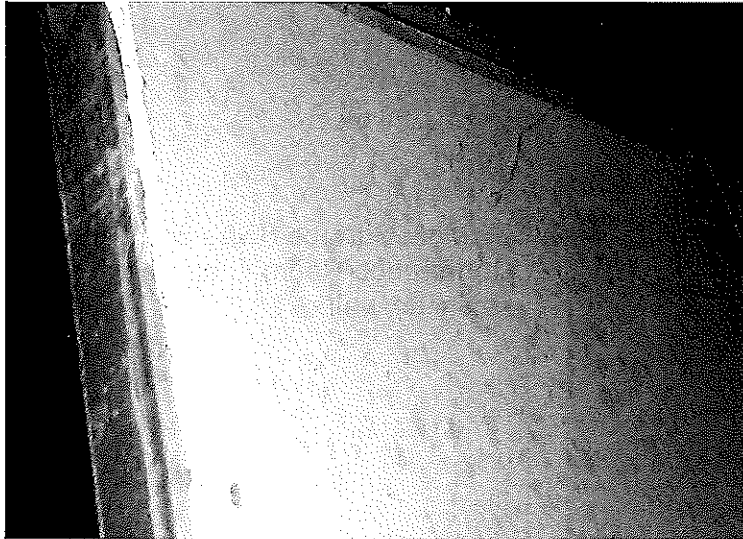
10. Mold Surface Swab Sample 07
– Conference Room 4, upper north
drywall wall above ceiling tiles

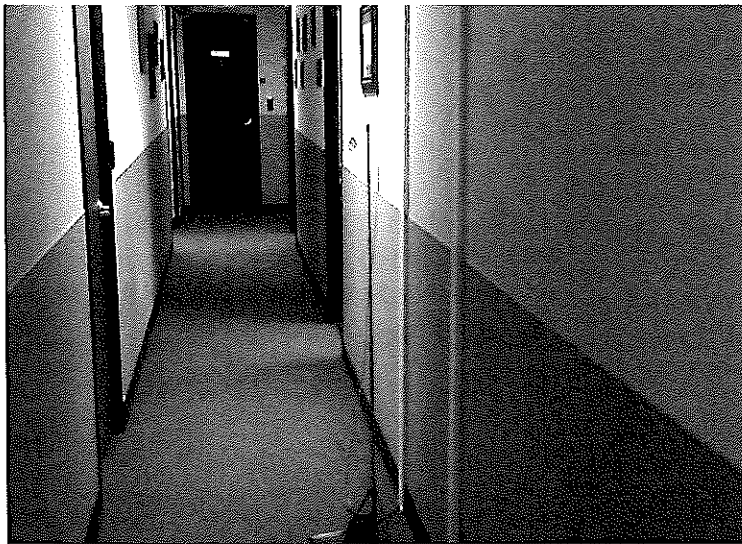
Detectable trace levels of *Stachybotrys* mold spores (13 spores per cubic meter) were present in the Hall area south of Conference Room 4 (Air Sample 16). *Stachybotrys* is a moisture damage indicator mold that commonly grows on porous building materials (such as drywall, cellulose ceiling tiles, or materials with paper backings) in buildings that have been impacted by sustained or ongoing moisture sources.

19. Mold Ambient Air Sample 16 –
Hall area south of Conference Room
4

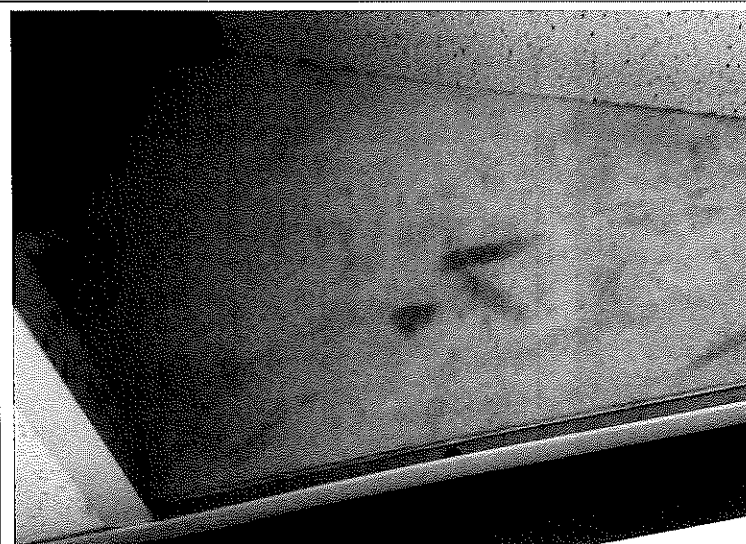
21. Mold Surface Swab Sample 18
– Hall east of Conference Room 2,
upper west vinyl-covered drywall
wall above ceiling tiles

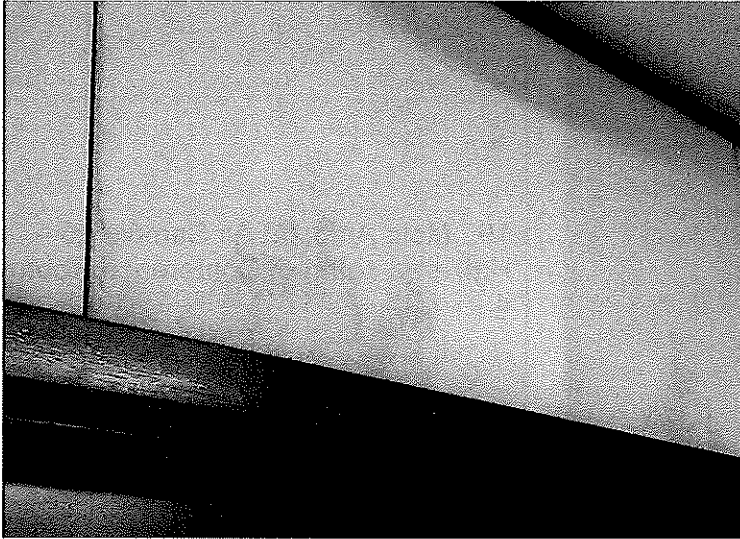
22. Mold Surface Swab Sample 19
– Break Room, upper west vinyl-
covered drywall wall above the door
frame (below ceiling tiles)

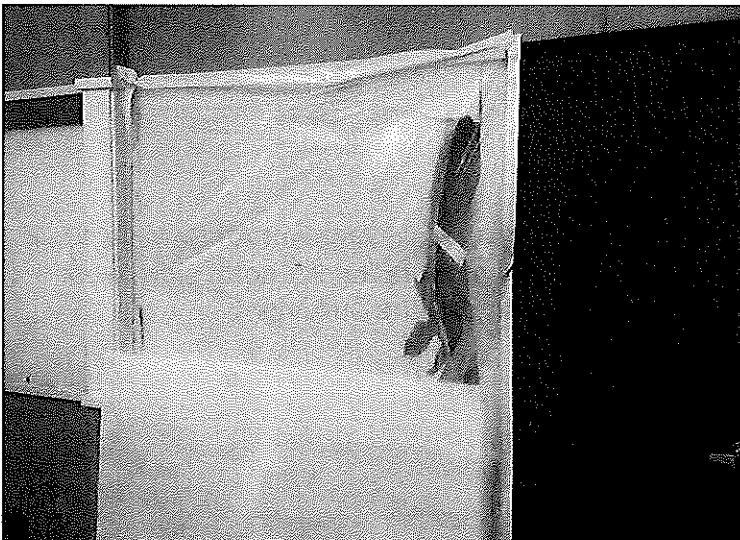
23. Conference Room 4 – View of
the north wall where a plexiglass
wall panel and drywall wall section
have been removed and the wall
cavity area exposed

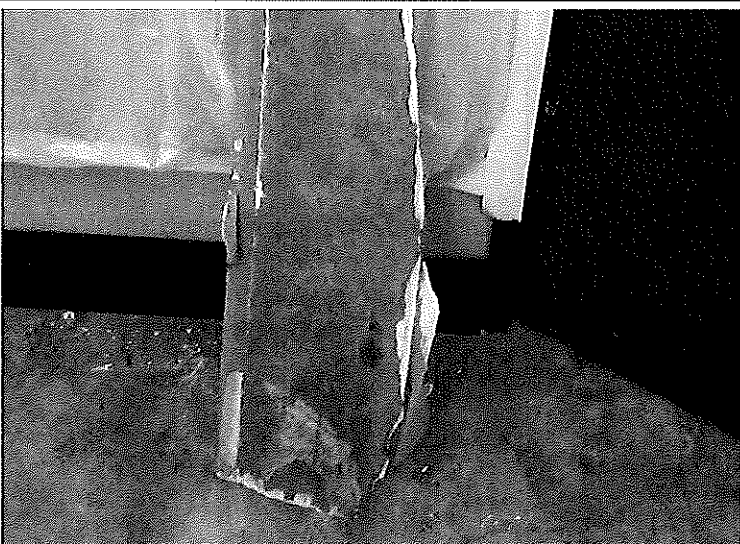
24. Conference Room 4 – View of
visible mold growth on the back side
of drywall removed from the north
wall

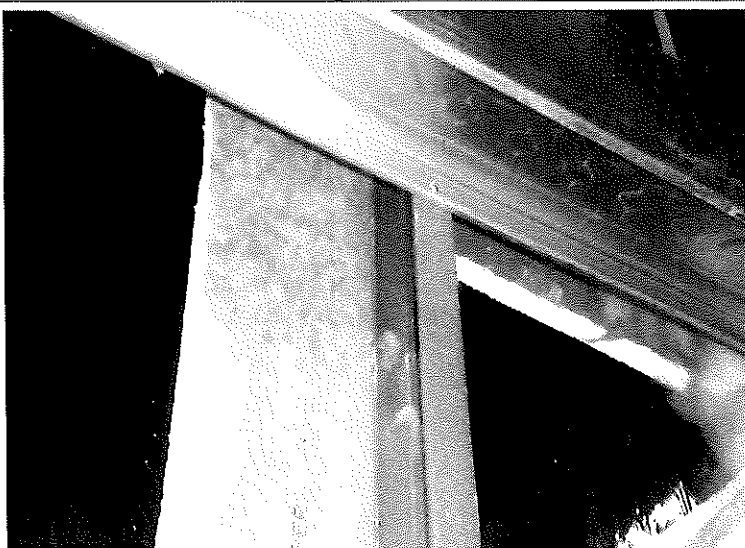
25. Conference Room 4 – View of visible mold growth on the upper east drywall wall above the ceiling tiles

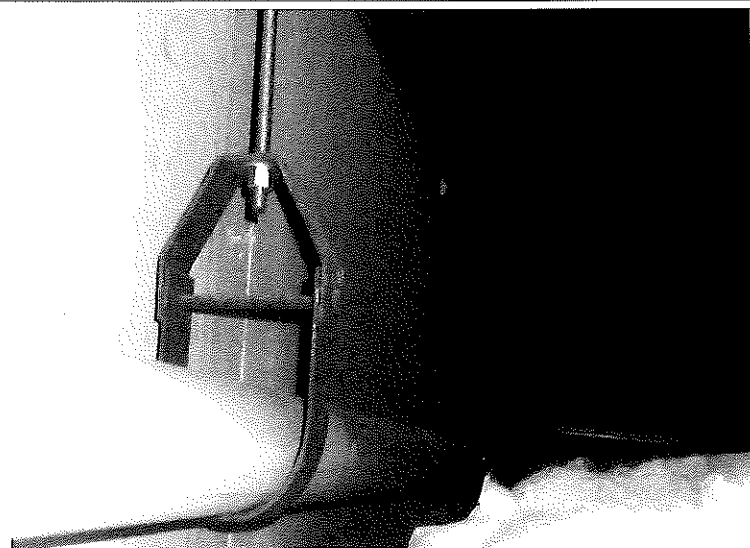
26. Conference Room 4 – View of visible mold growth on the upper north drywall wall above the ceiling tiles

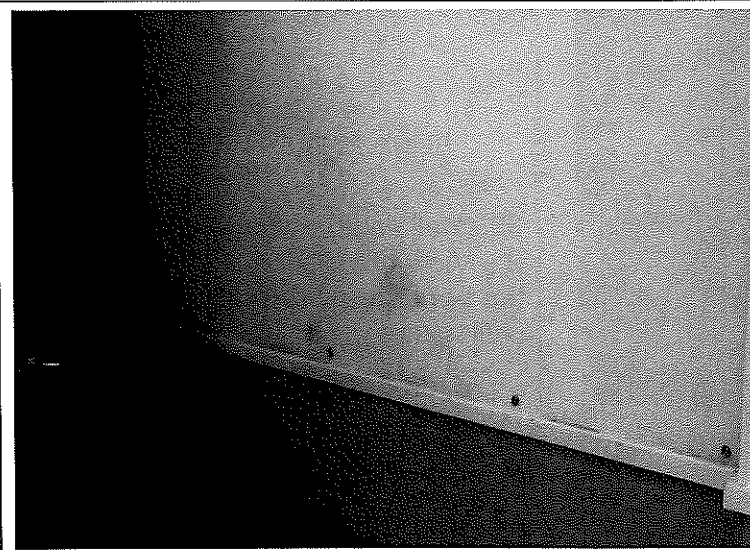
27. Conference Room 4 – View of visible mold growth on wall surfaces behind plexiglass panels

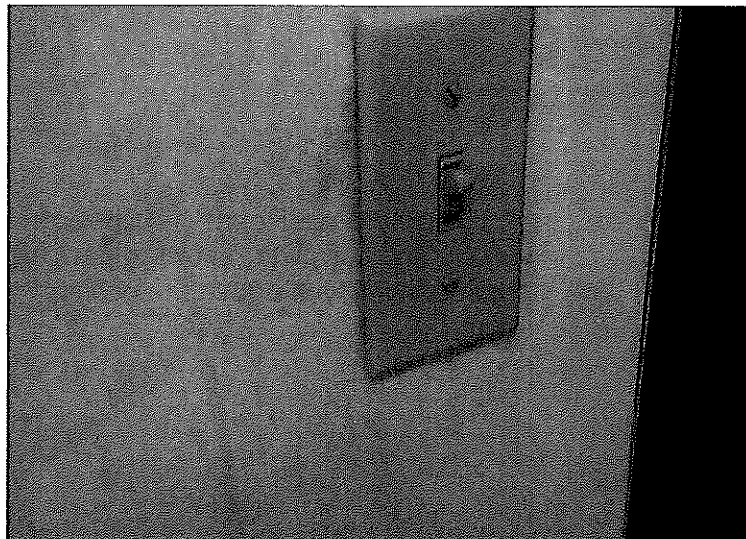
28. Conference Room 2 – View of visible mold growth on wall surfaces behind plexiglass panels

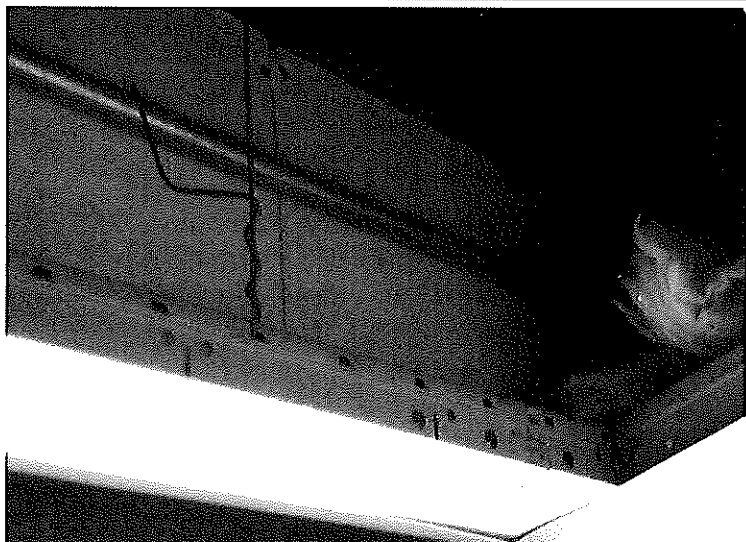
29. Hall south of Conference Room 2 – View of visible mold growth on the upper north vinyl-covered drywall wall above ceiling tiles

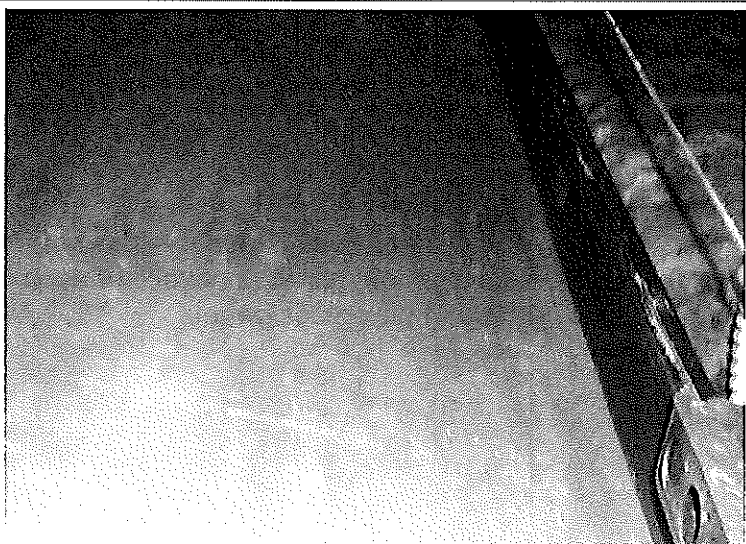
30. Hall south of Conference Room 2 – View of visible mold growth on the upper north drywall wall above ceiling tiles

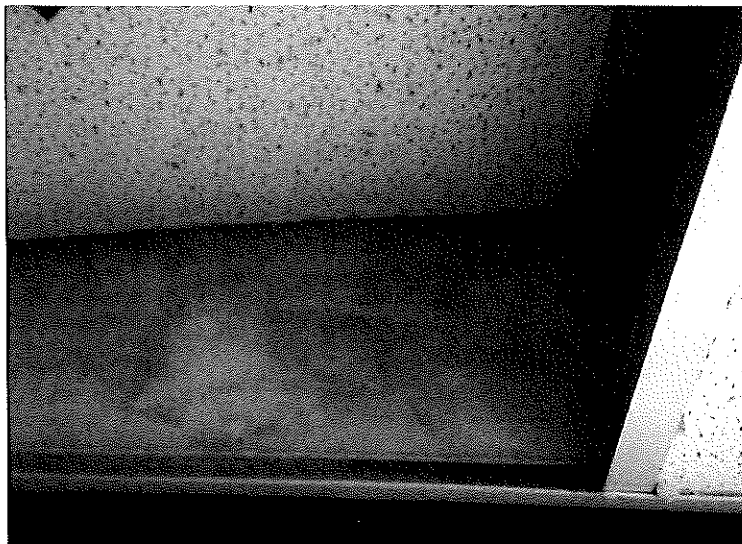
31. Hall east of Conference Room 2 – View of visible mold growth on the upper east vinyl-covered drywall wall above ceiling tiles

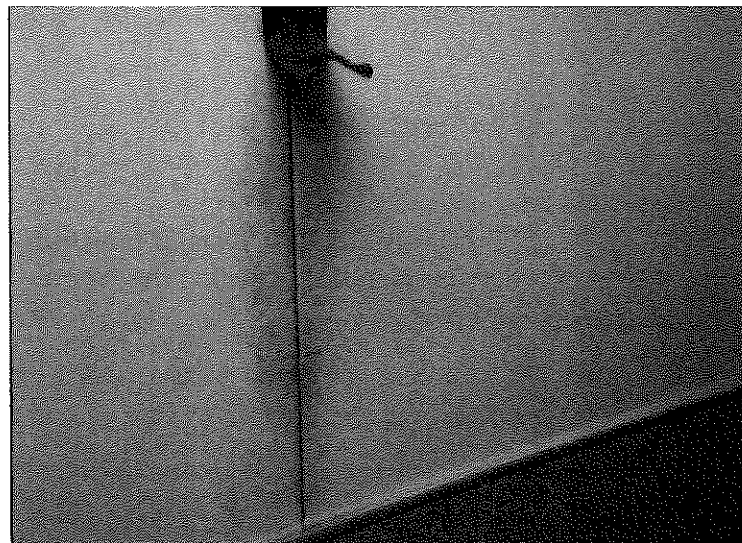
32. Hall south of Conference Room 2 – View of visible mold growth on the north vinyl-covered drywall wall (fire extinguisher area)

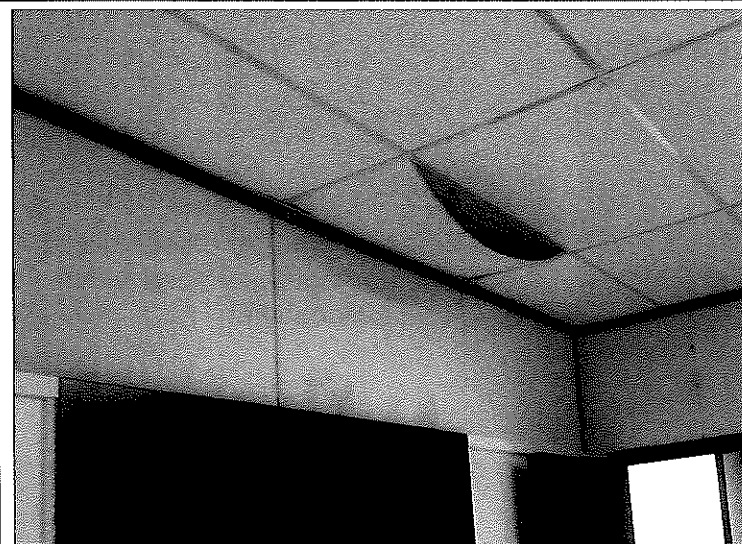
33. Break Room – View of visible mold growth on the upper west and north vinyl-covered drywall walls

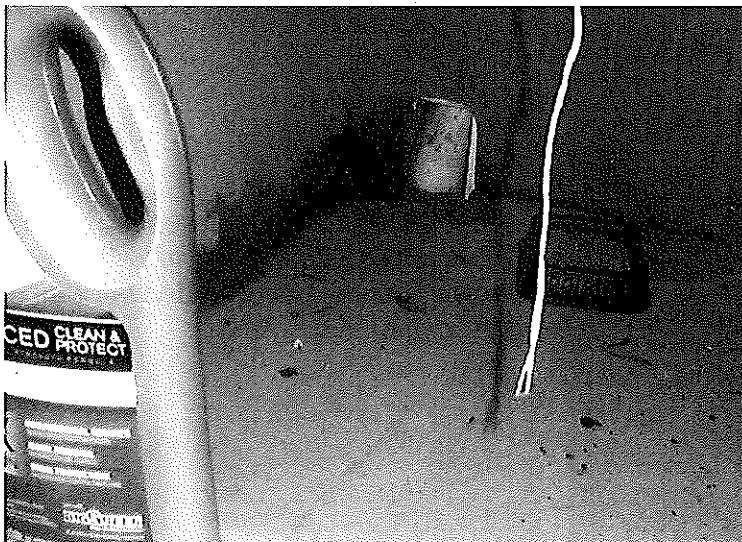
35. Break Room – View of moisture damaged surfaces within the wood sink cabinet

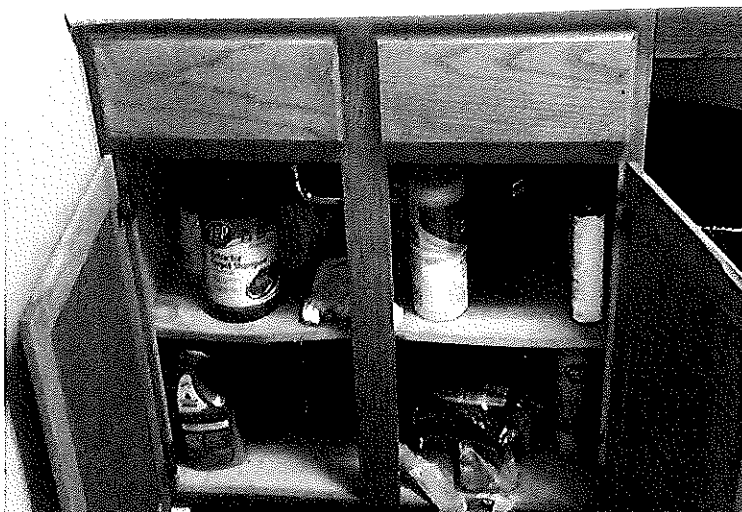
36. Break Room – Another view of moisture damaged surfaces within the wood sink cabinet

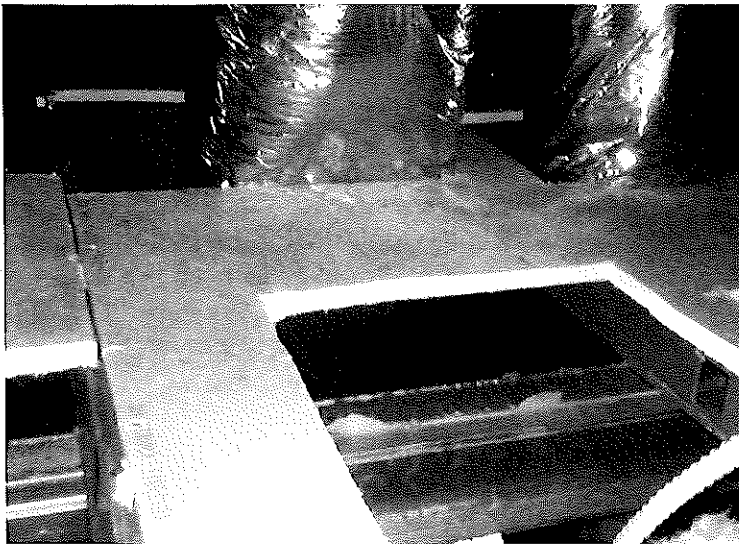
37. Break Room – View of visible mold growth on the upper west drywall wall above ceiling tiles

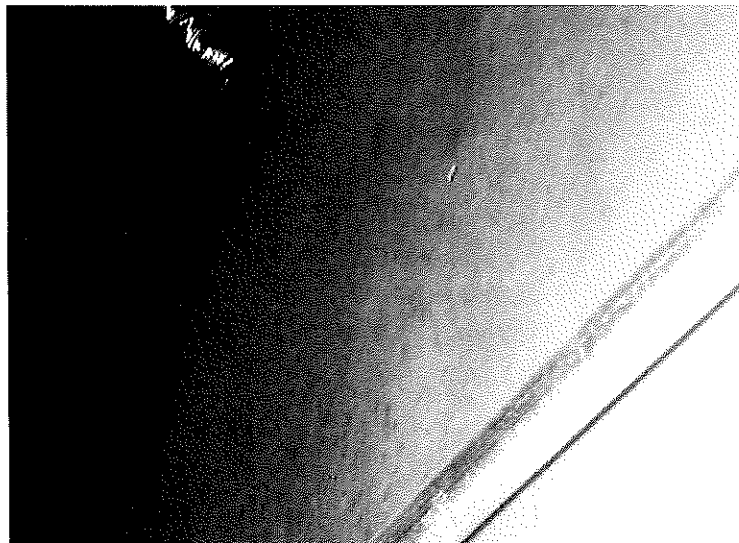
38. Break Room – View of visible mold growth on the upper east drywall wall above ceiling tiles

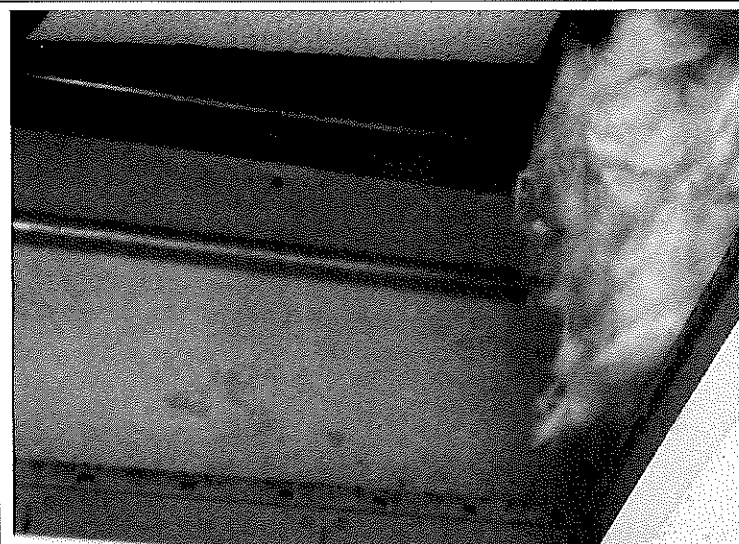
39. Hall south of the Break Room – View of visible mold growth on the upper north vinyl-covered drywall wall above ceiling tiles

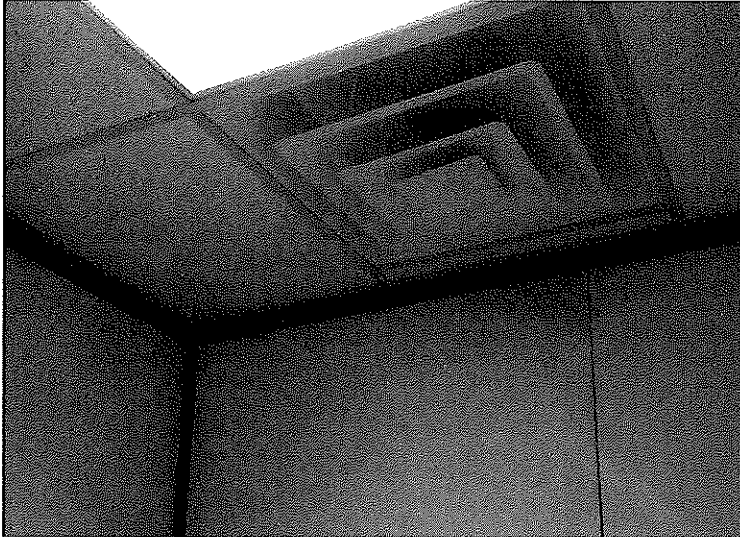
40. Small Restroom adjacent to the South Central Storage Room – View of visible mold growth on the upper west and north vinyl-covered drywall walls (near the air supply vent)

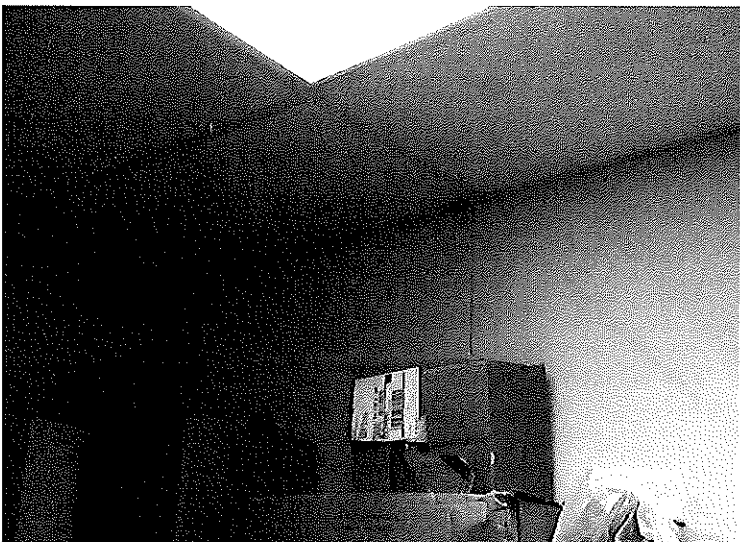
41. Storage Room 9 – View of visible mold growth on the upper east and north vinyl-covered drywall walls

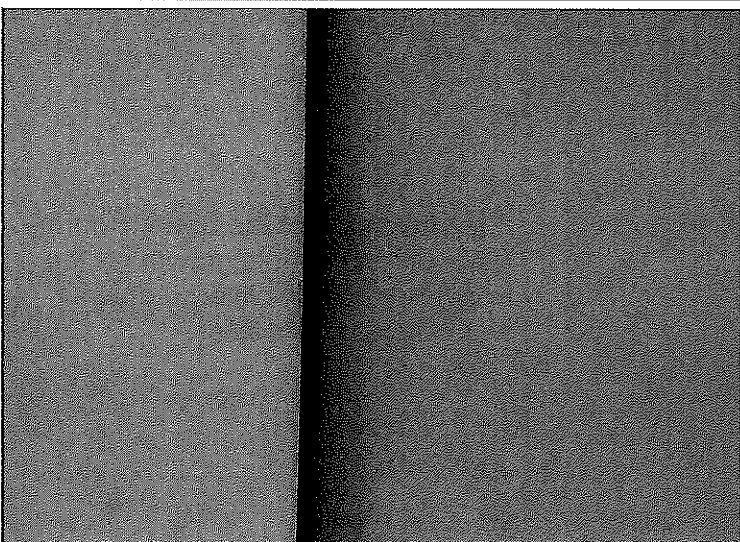
42. Room 3 – View of visible mold growth on the east and north vinyl-covered drywall walls

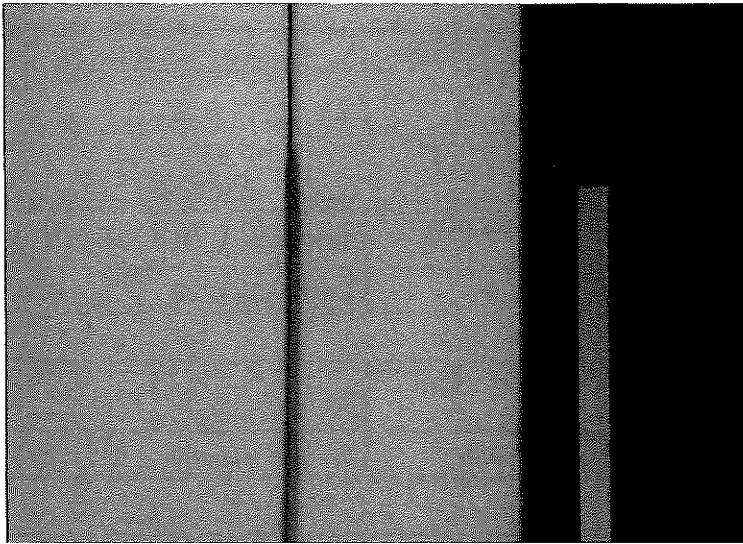
43. Room 3 – View of visible mold growth on the south vinyl-covered drywall wall

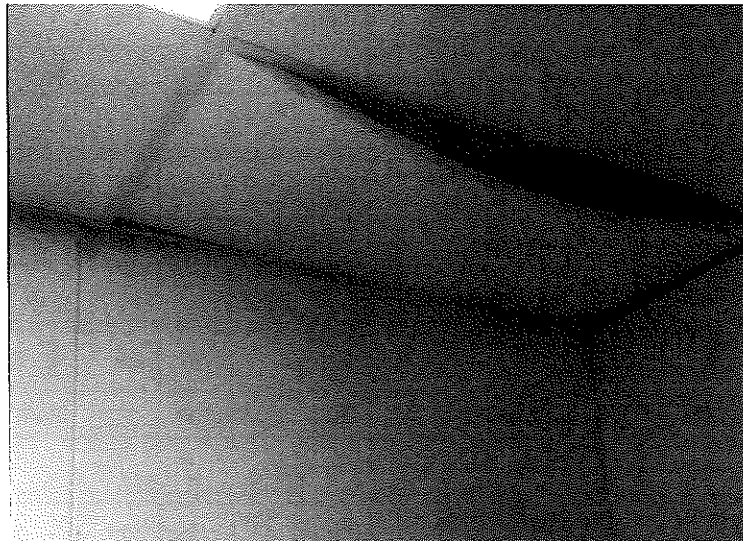
44. Another example view of visible mold growth on upper vinyl-covered drywall wall surfaces

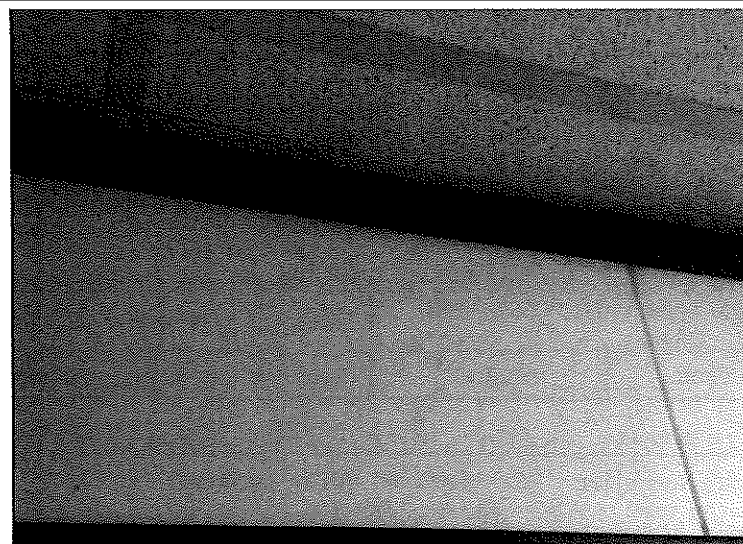
45. Another example view of visible mold growth on upper vinyl-covered drywall wall surfaces
